# Introduction to The Tipping Bucket Rain Gauge

Dr John Gorman, ARIC

# Rimco 7499 Tipping Bucket Rain Gauge (TBRG)

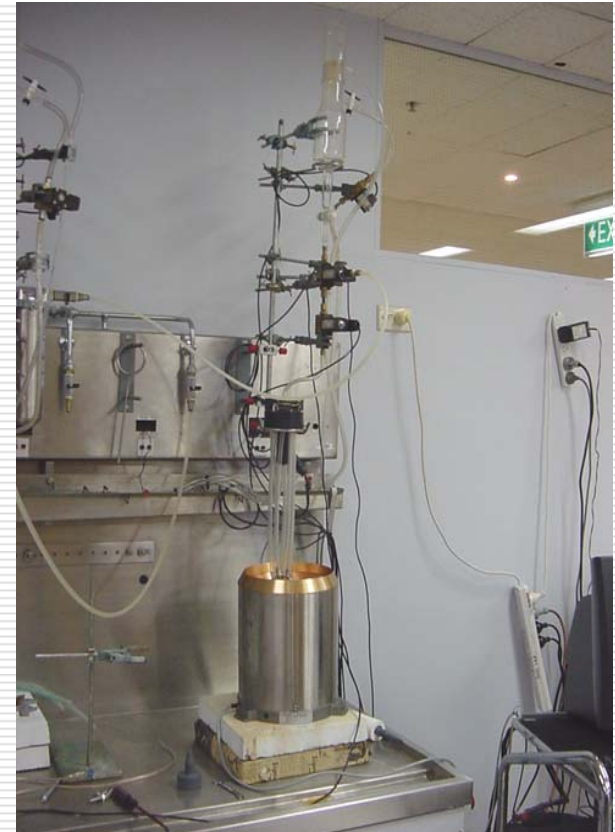
# TBRG Testing -10 Years Ago

- Gravity fed Boyle bottles
- Tests showed the variation was approximately  $\frac{1}{4}$  of a tip.
- Lack of select ability of flow rate due to the limited number of nozzles (6) and their fixed size.
- Variability of flow rate due to nozzles becoming blocked with time.
- Variability of nozzle flow from run to run.

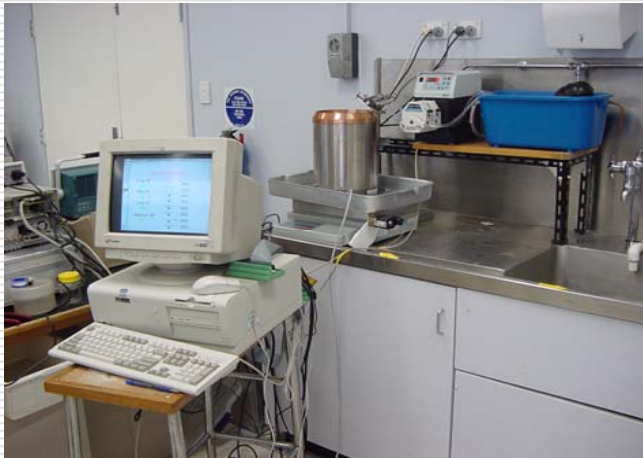
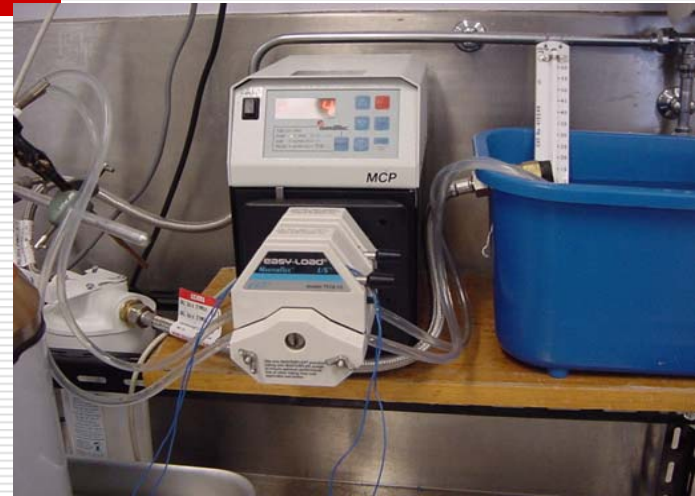
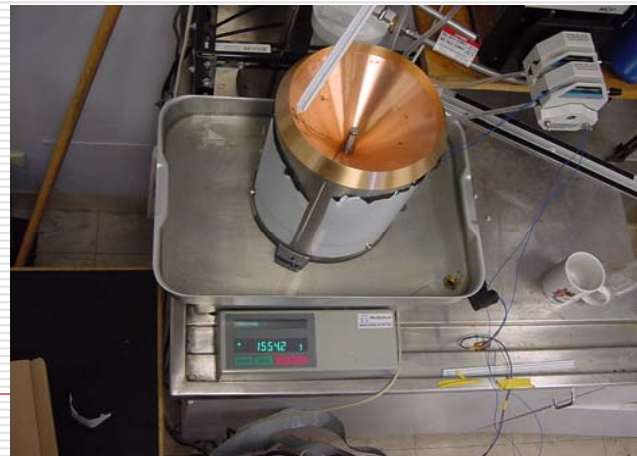
# 5 Years Ago - Peristaltic Pump

- Some drift in rainfall rate (approx. 0.5% per 24 hours of operation)
  - Tubing needs regular replacement (once a week during continuous operation).
  - Equipment of the systems is expensive, approx \$15k each system.
  - Minimum of 300 tips required to reduce biases in the 'taring' method.
-

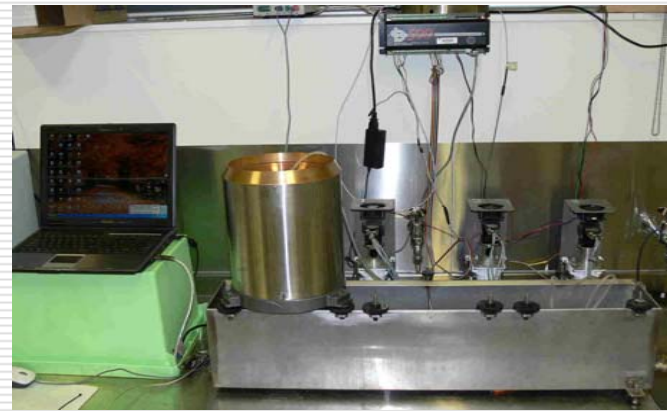
# Now ..... Pump-Stepper Motor System.

- extends range down to  $\leq 2 \text{ mm.hr}^{-1}$
- High precision in RFI and tips

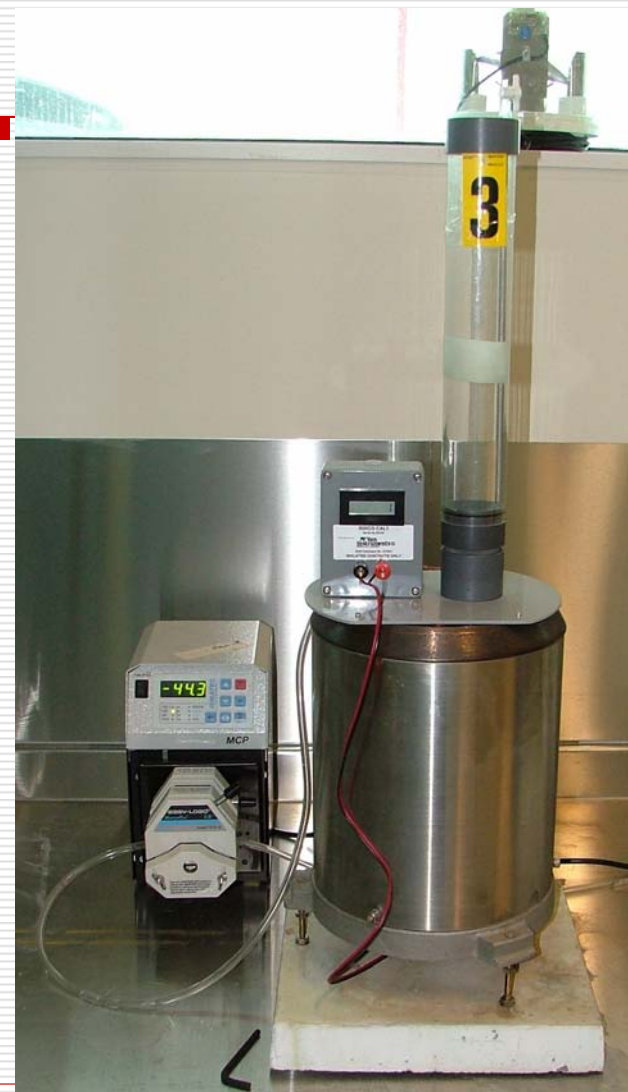
# Manual testing with HS Field Calibration Devices (FCD)

- Gauges are also tested manually using 200 mm.h<sup>-1</sup> FCDs (Volume ~ 654 ml).
- This is done because it:
  - confirms the results of the automated testing;
  - replicates the field calibration of the gauge;
  - is quicker.
